Annual Water Program - 1970

SUBJECT: Tewaukon NWR - 1970 Annual Water Program

ANNUAL WATER PROGRAM - TEWAUKON FUGE

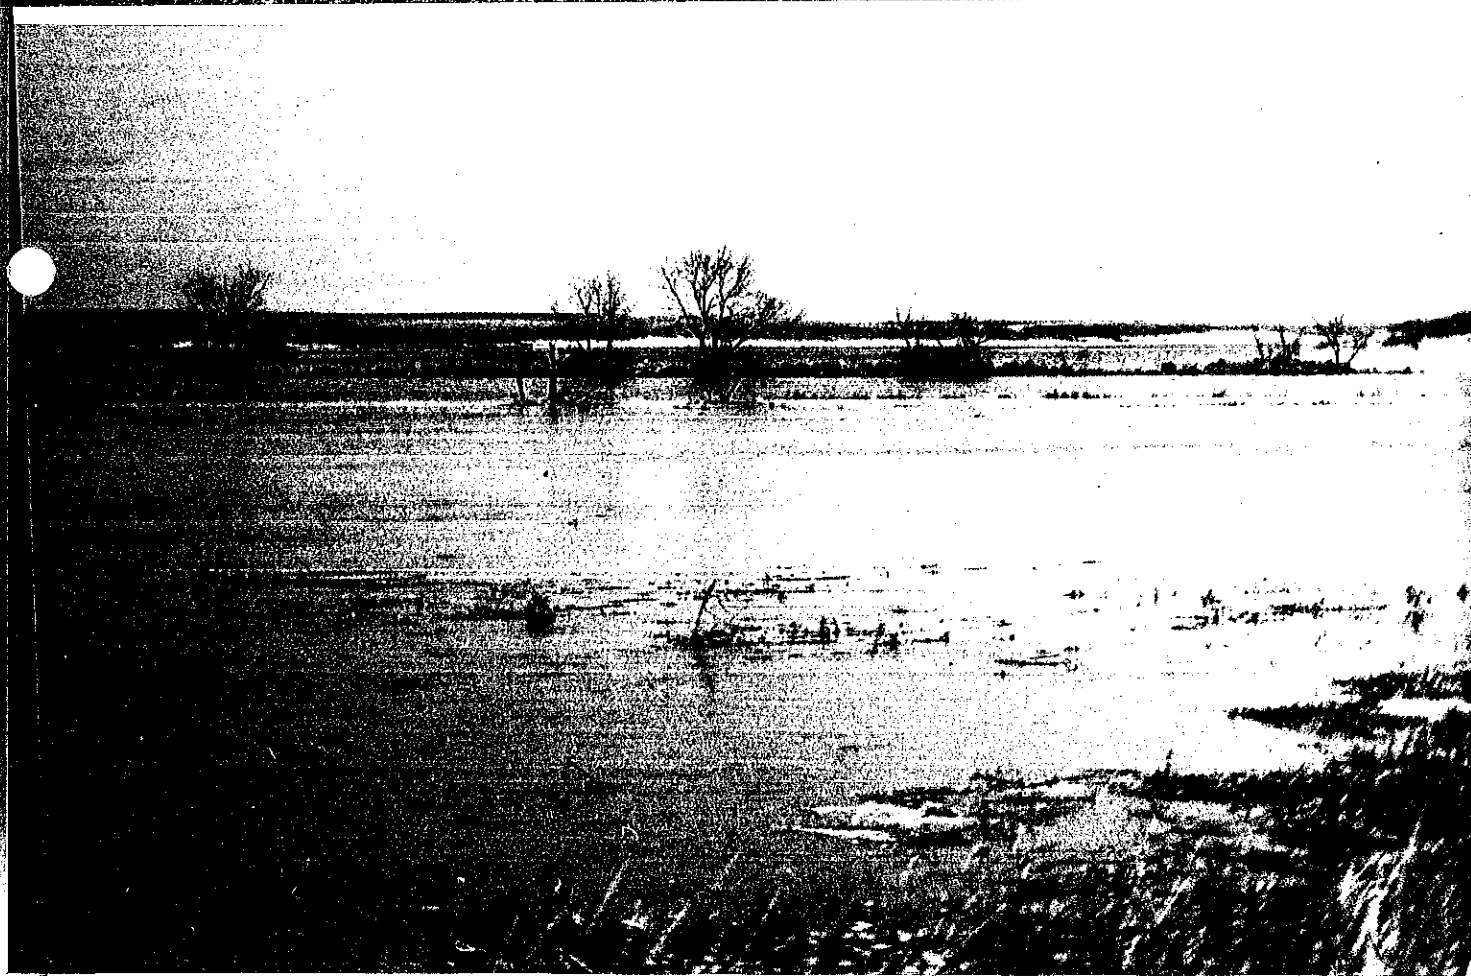
Photo #2 - From the township road just east of Dam 4,
looking east to the old Nickeson Dike, overtopped
by flood water. We widened this some last year, but
it has got to be rebuilt. We cannot properly manage
Pool 3 until it is. Or we should attempt to buy
Ed Nickeson's land beyond, which is the best solution.

In regards to the Nickerson Dike, there are no funds available at the present time to remedy the seepage problem. We would suggest that the manager continue to hold the water level in pool 3 as low as possible so as to prevent seepage to private land.

We ought to leave Pool 3 dry all summer, providing we can rebuild or repair the Nickeson Dike. Any water in Pool 3 will either cause seepage through the Nickeson Dike or maybe prevent water from seeping out of the dike from Nickeson's private farmland. I believe we cannot allow our management to further flood his land and if we can drain the water off his land without conflict to our operations, we should do it. In fact, we'll probably have to cut the dike to drain water out before we can repair it.

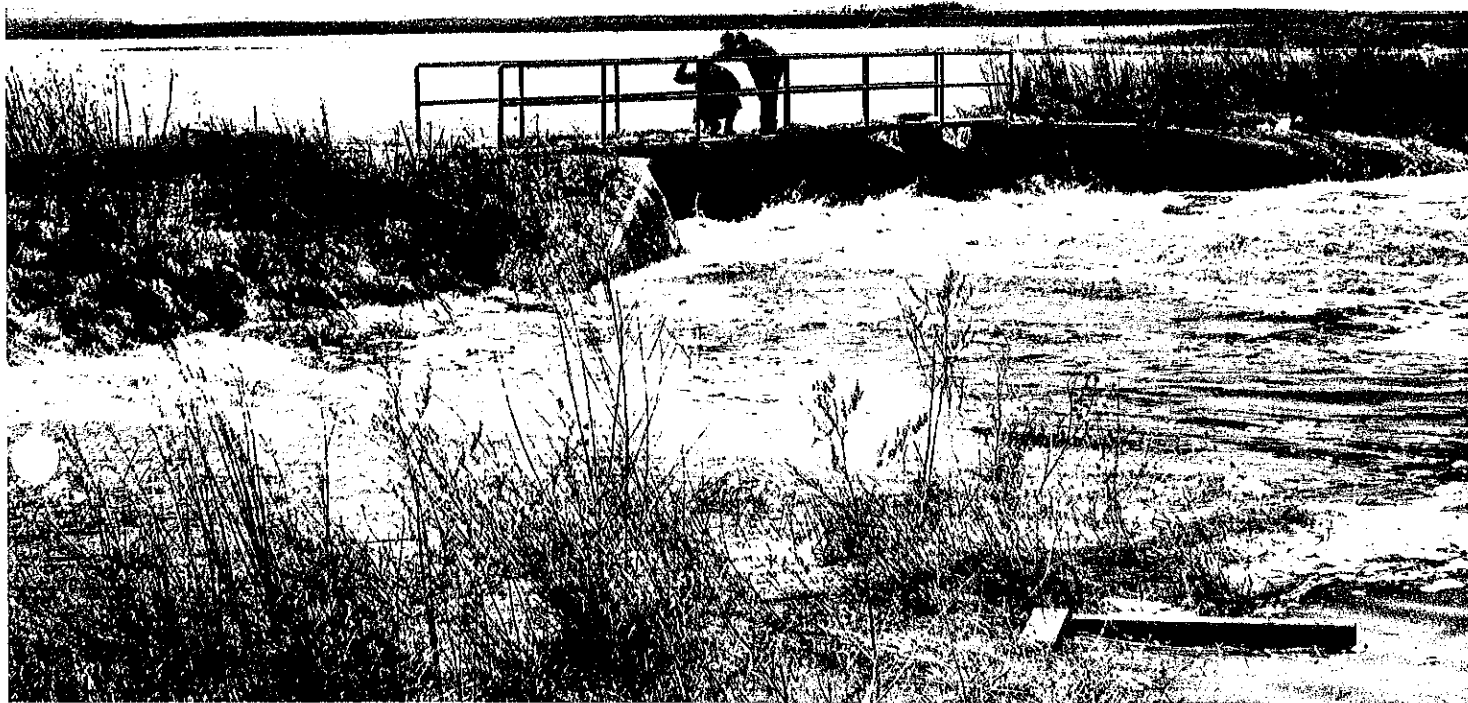
Photo #3 - Dam 2 with flood water running over it.

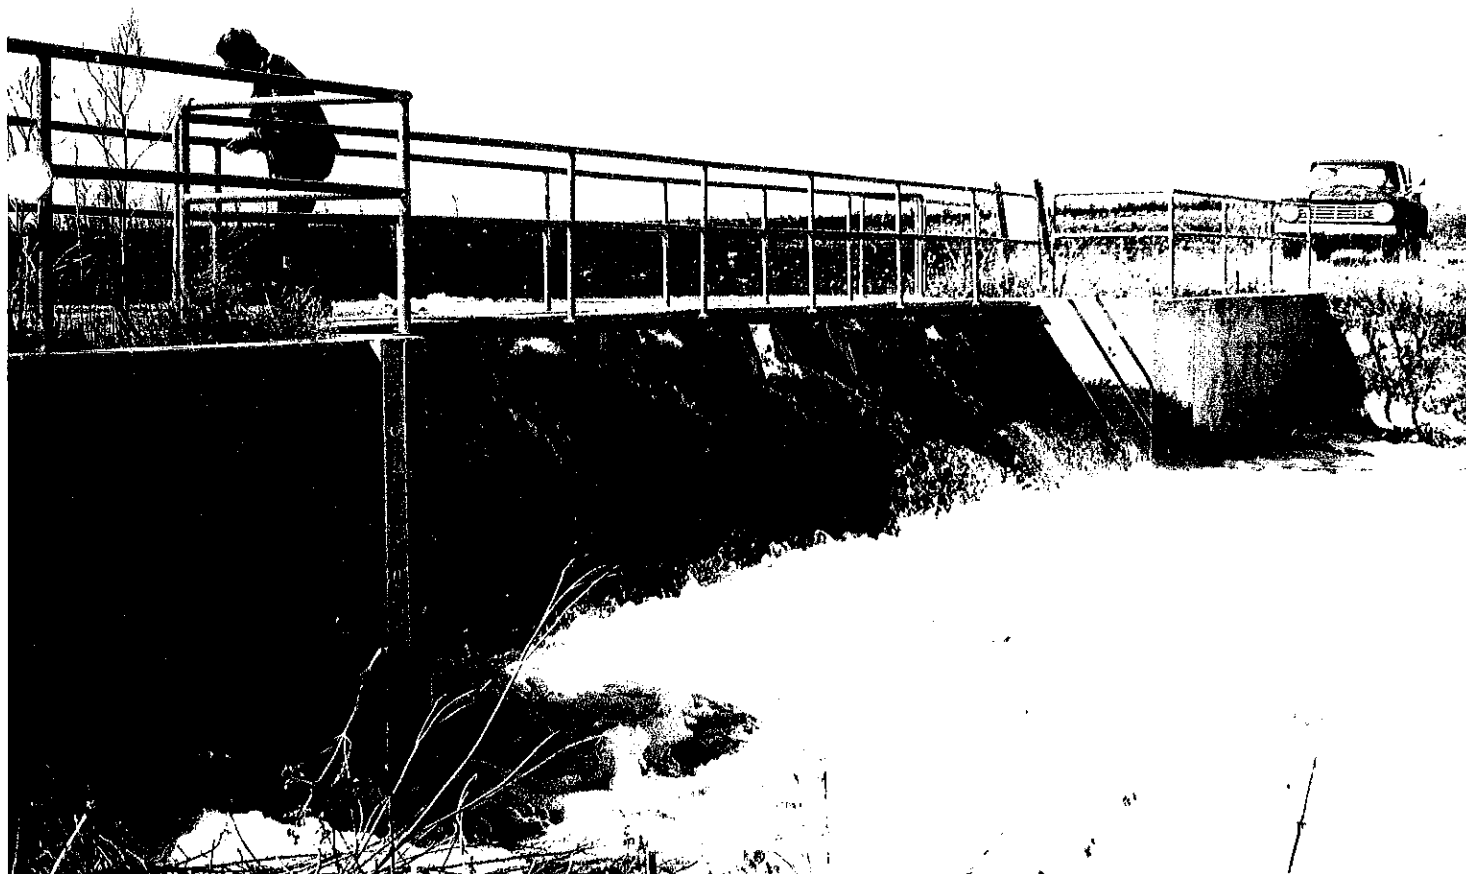
Photo #4 - Dam 1 about the time the flood crested. Water ran over the dike at the north end of the structure. Our heavy carp barriers could not be pulled with the large flow of water, so most stop-logs were in place.

Carp screens for the control structures should not be an impediment to the operation of the structures. If they do, then we suggest that they be replaced with screens that would not prohibit manipulation of the stoplogs.

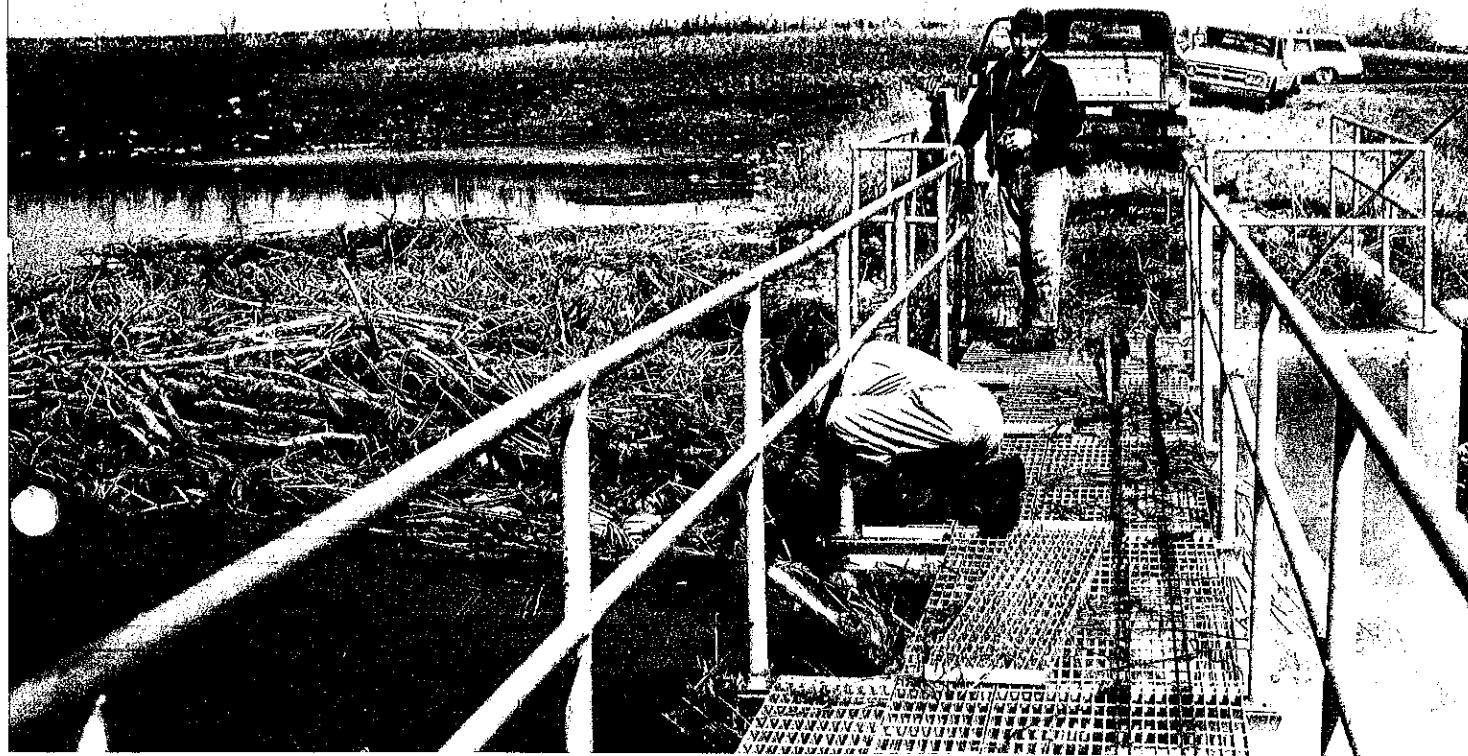
Photo #5 - Dam 1 showing trash washed against it.
Gary Krause looking on, whose own land was flooding
from Pool 1 at this time.

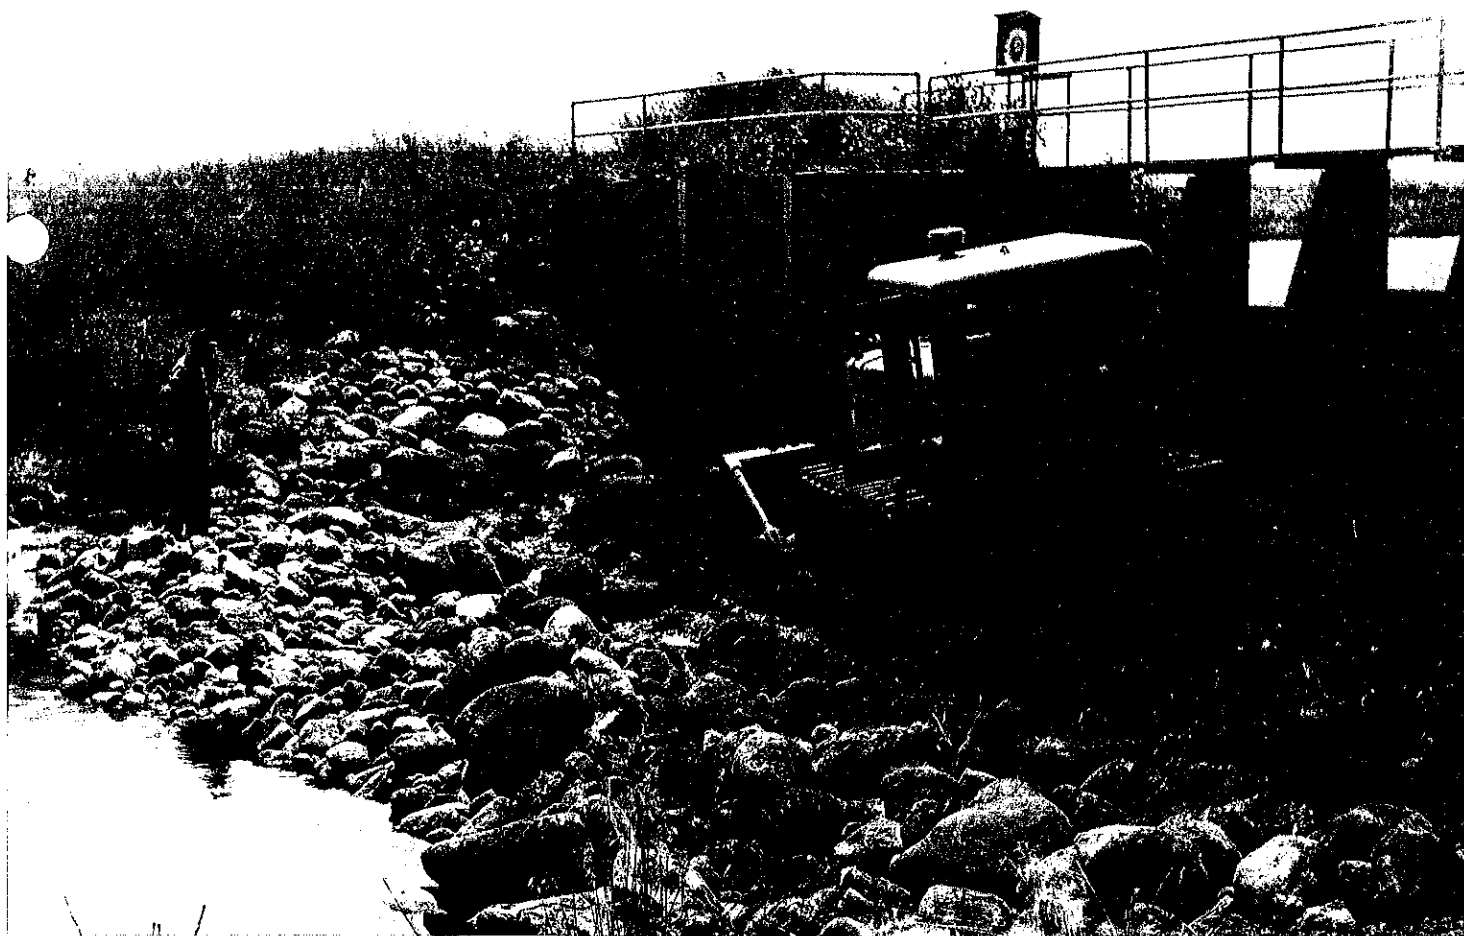
Photo #6 - A very deep hole scoured out downstream
of Dam 1. We hauled 40 loads of rock and pushed
them into this hole. This repaired flood damage
to Dam 1.

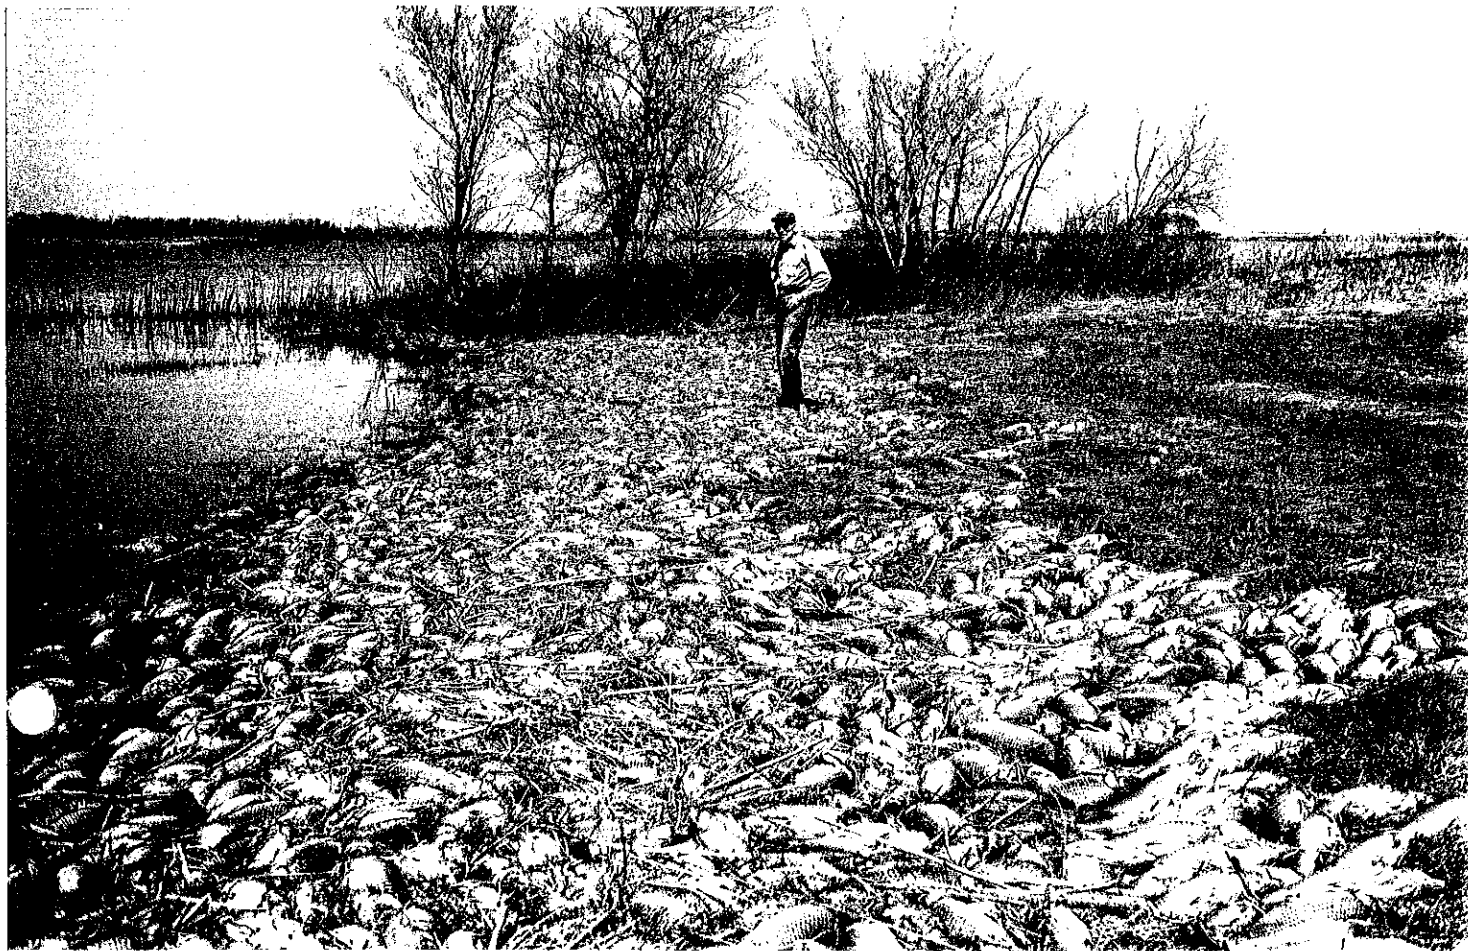
Photo #7 - Most fish winter killed in Lake Tewaikon.
Our carp problem was alleviated, but we lost a very
fine walleye fishery.

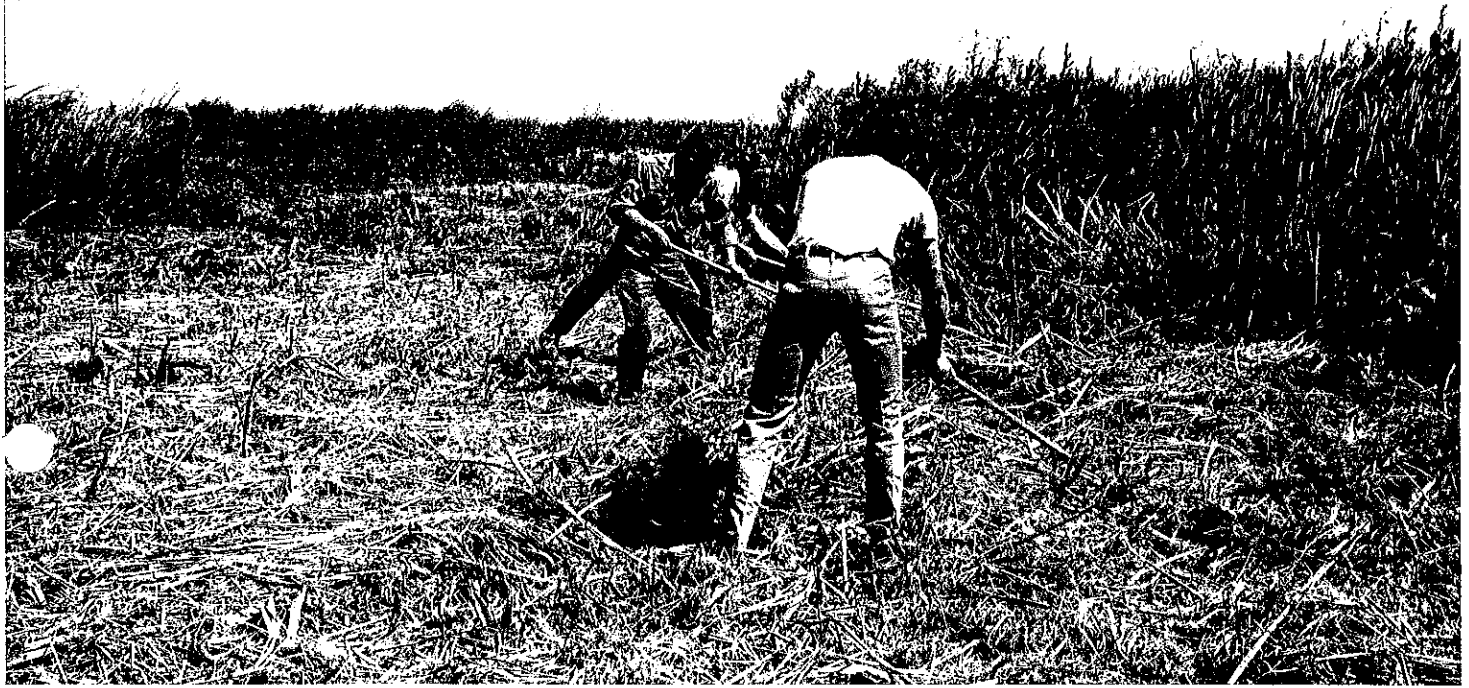
Photo #15 - Cattail is a problem, especially in Pools 5 and 6 and 2A. We dried up Pools 5 and 6, mowed and burned cattail and willows, and cultivated the pool bottoms. We seeded them to rye for flooding in the spring of 1970 as a green crop for invertebrate production for waterfowl.

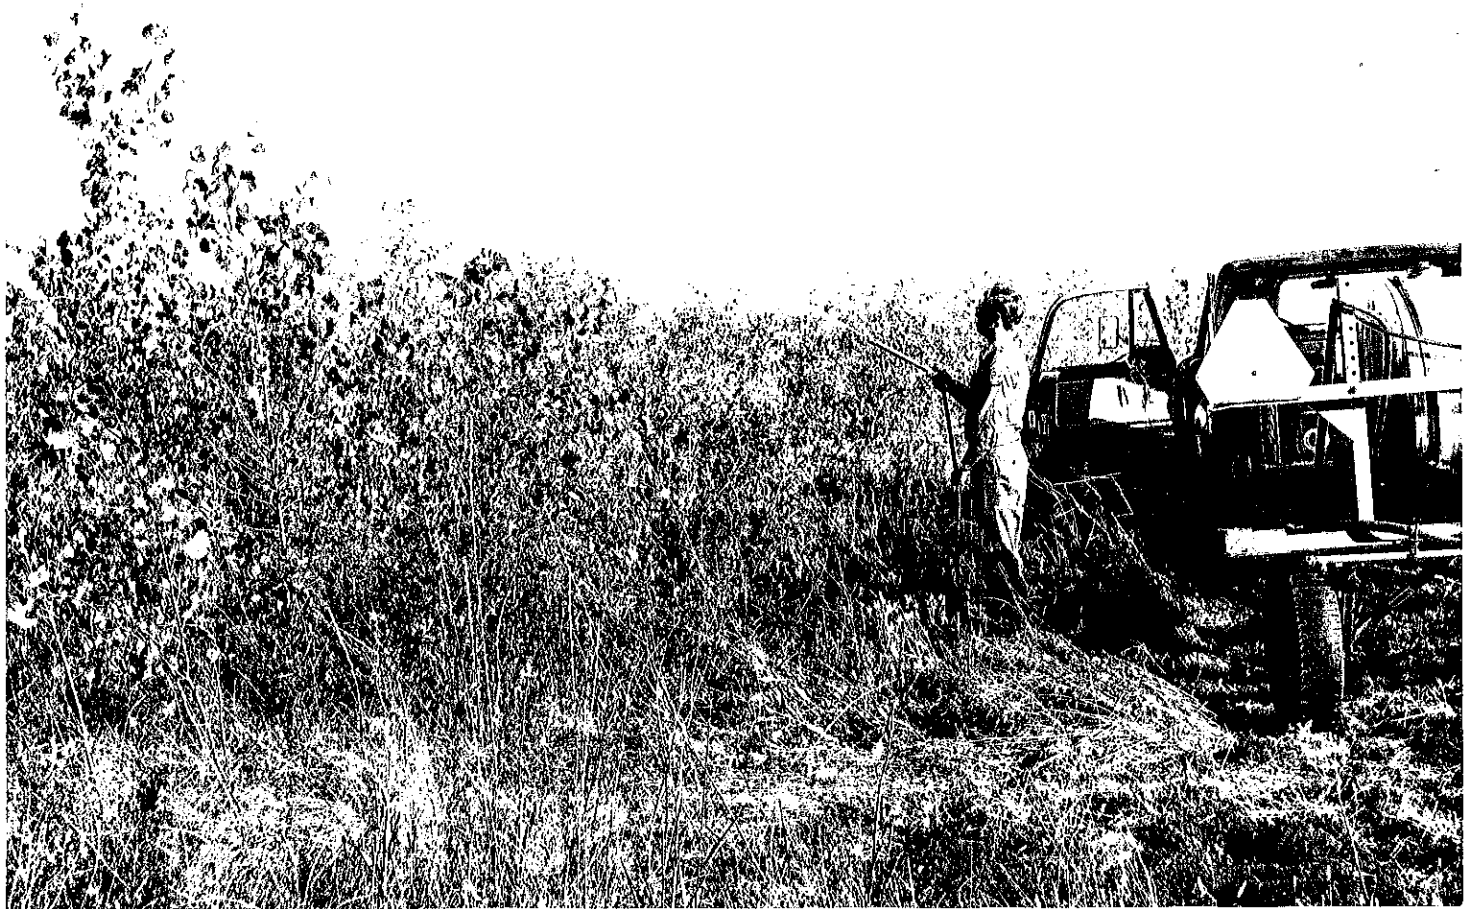
Photo #16 - Willows and cottonwoods encroach around most potholes here. It will be a continual battle to keep these potholes open for waterfowl pair use. Spraying, mowing, dozing and burning are the methods we have to use. Mowing is hazardous until rock piles are cleaned up. Burning will probably be our best tool.

Regarding the problem of opening up the potholes that are being encroached upon by woody growth, Phragmites and Cattail, we have the following suggestion. After the ground freezes hard enough to support heavy equipment, shear a strip around the periphery of the pothole pushing sheared material towards center. This strip should be wide enough to provide a fire break area around the unsheared vegetation and the piles of sheared material. Burning

Burning these potholes to open them up appears to be a worthwhile approach, but this is difficult to do. Perhaps a combination of dozing open a fire break on the shoreline and then burning the potholes out with a snow cover may be the way to do this.
